Internal Framing
Of Cupola Columns

Looking West at East elevation

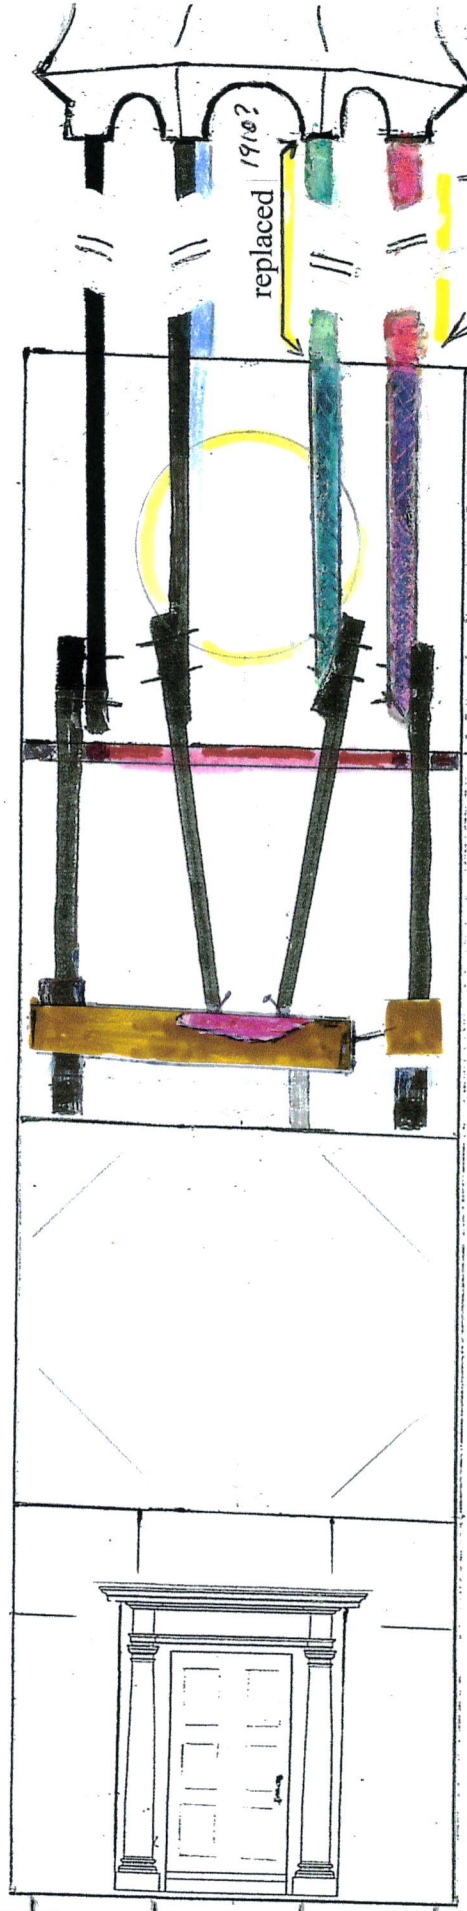
3.

Recommend replacement
-

Rotten
Needs replacement
-

Suspect
-

Needs replacement

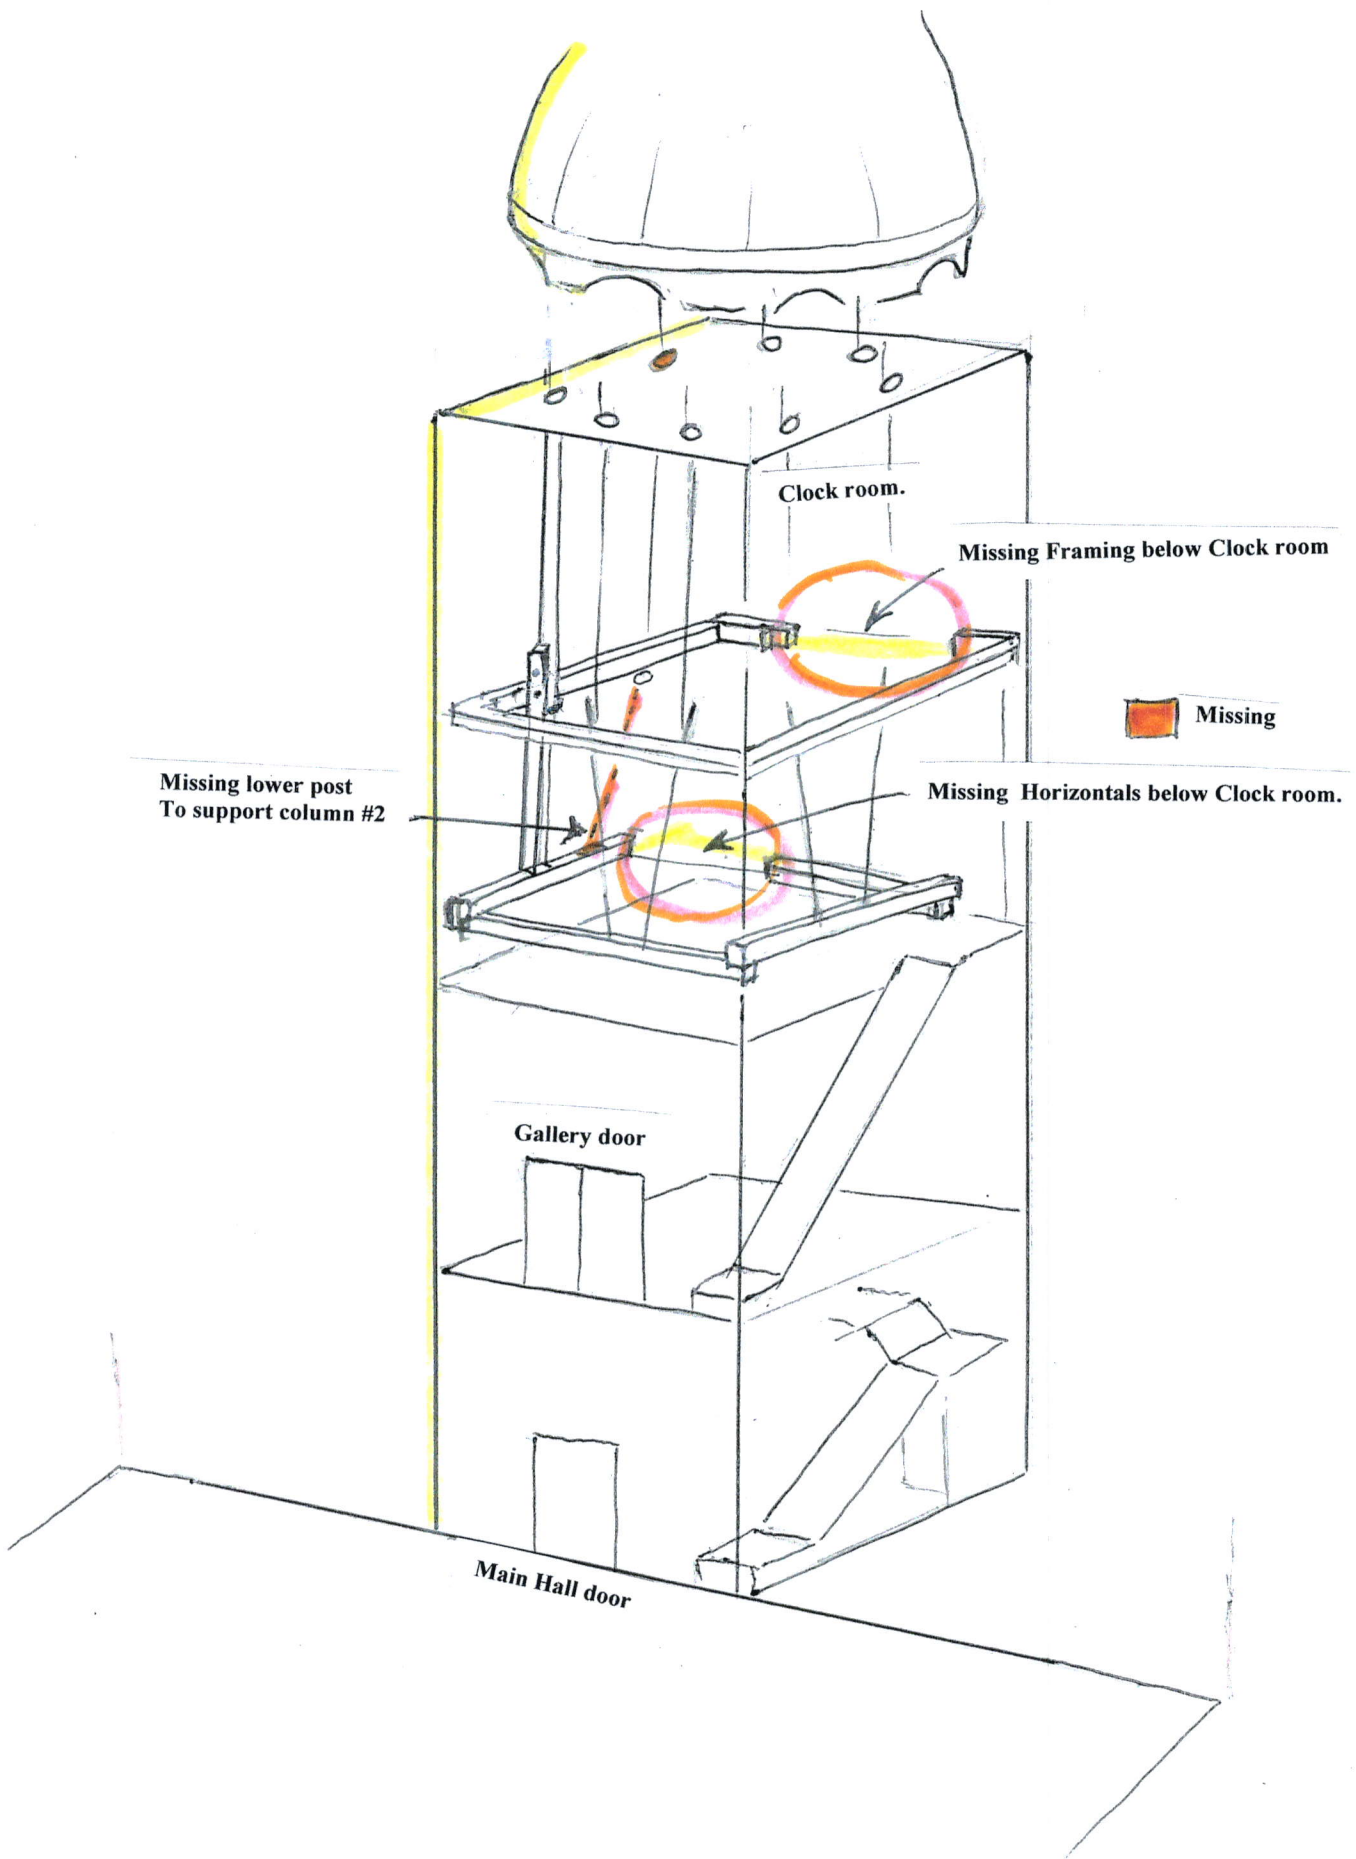
5.

Clock room.

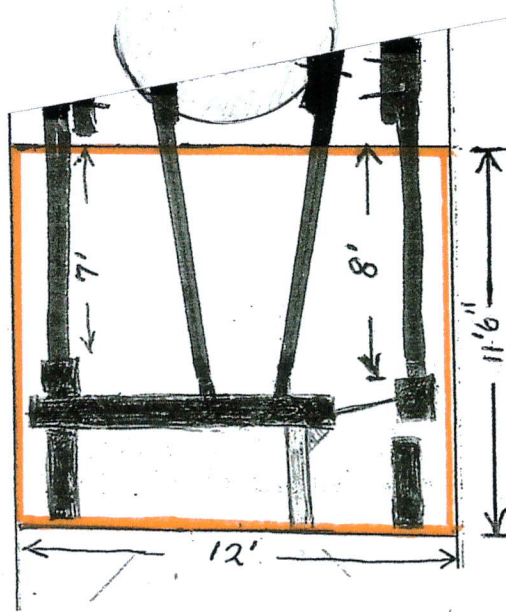
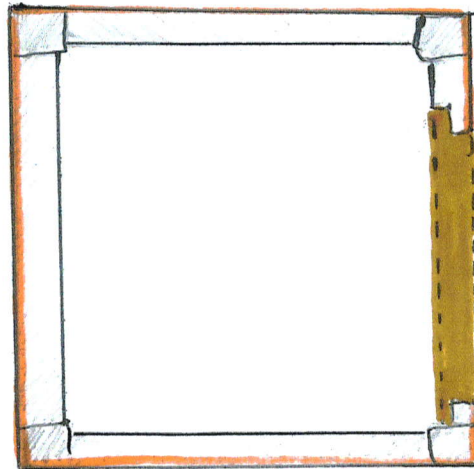
Missing Framing below Clock room

Missing horizontals

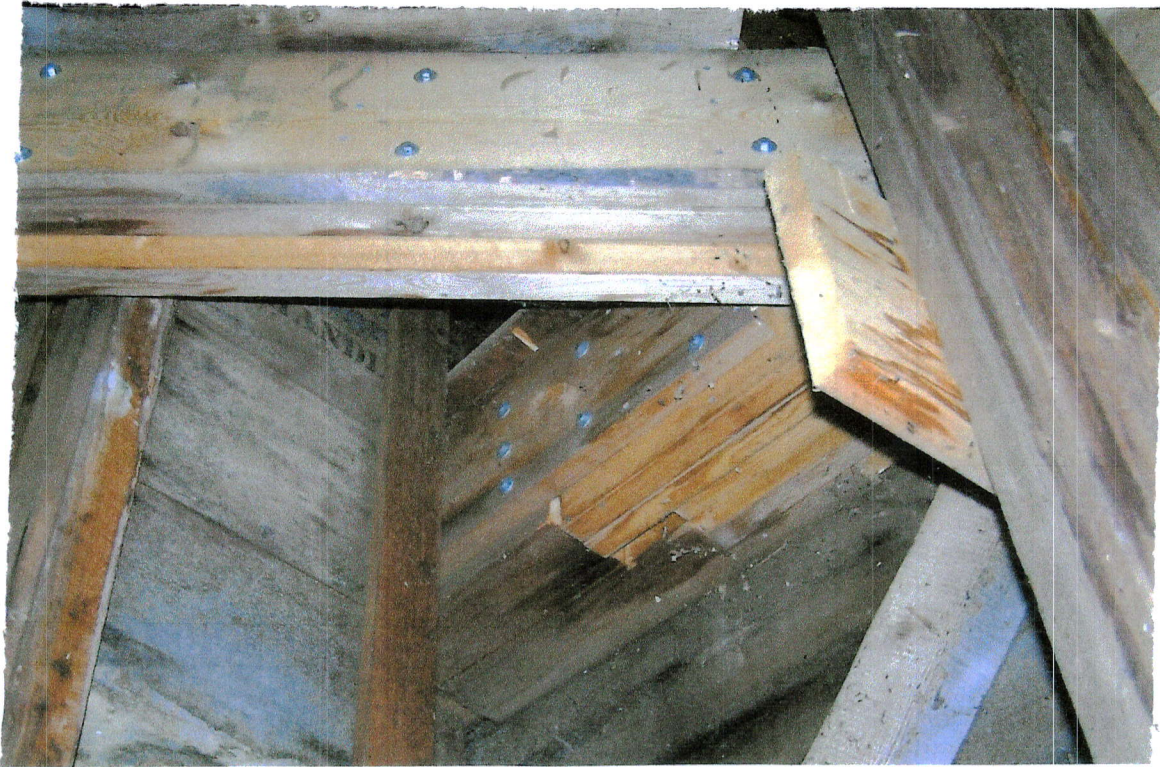
Repair beneath East clock room floor needing replacement. Provides little or no actual support to the structure.

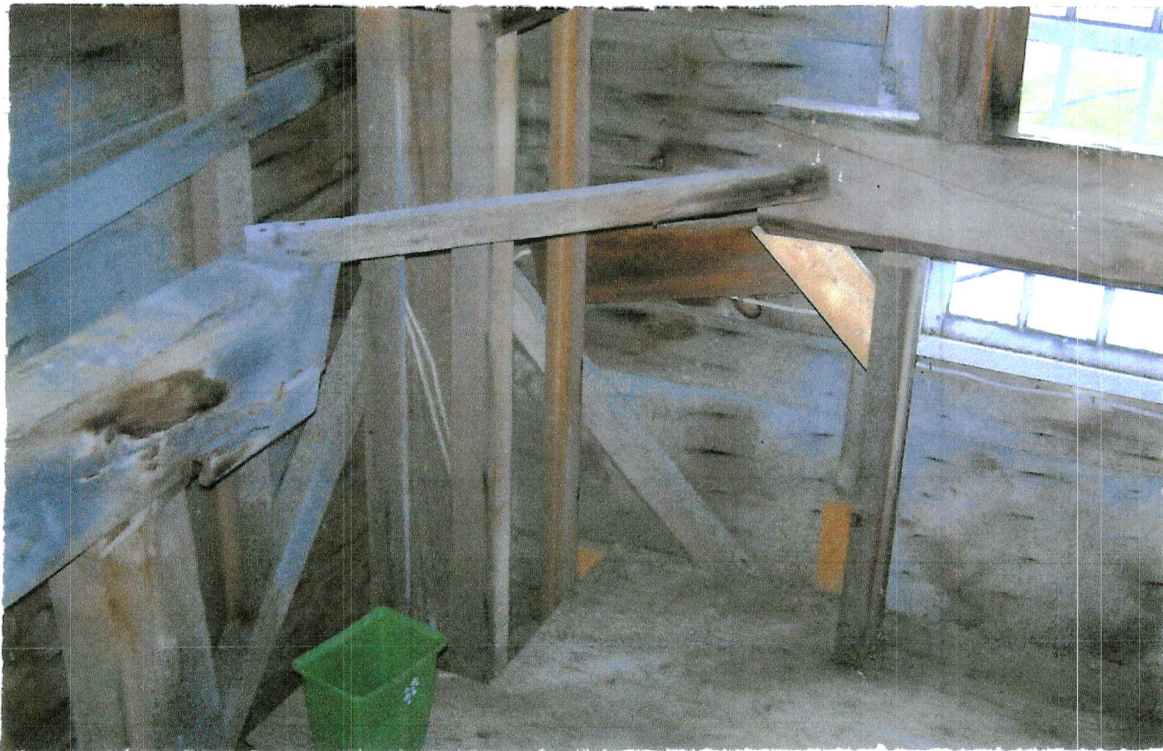
Missing 6x12" supports to lower cupola columns due to 1893 clock installation.
