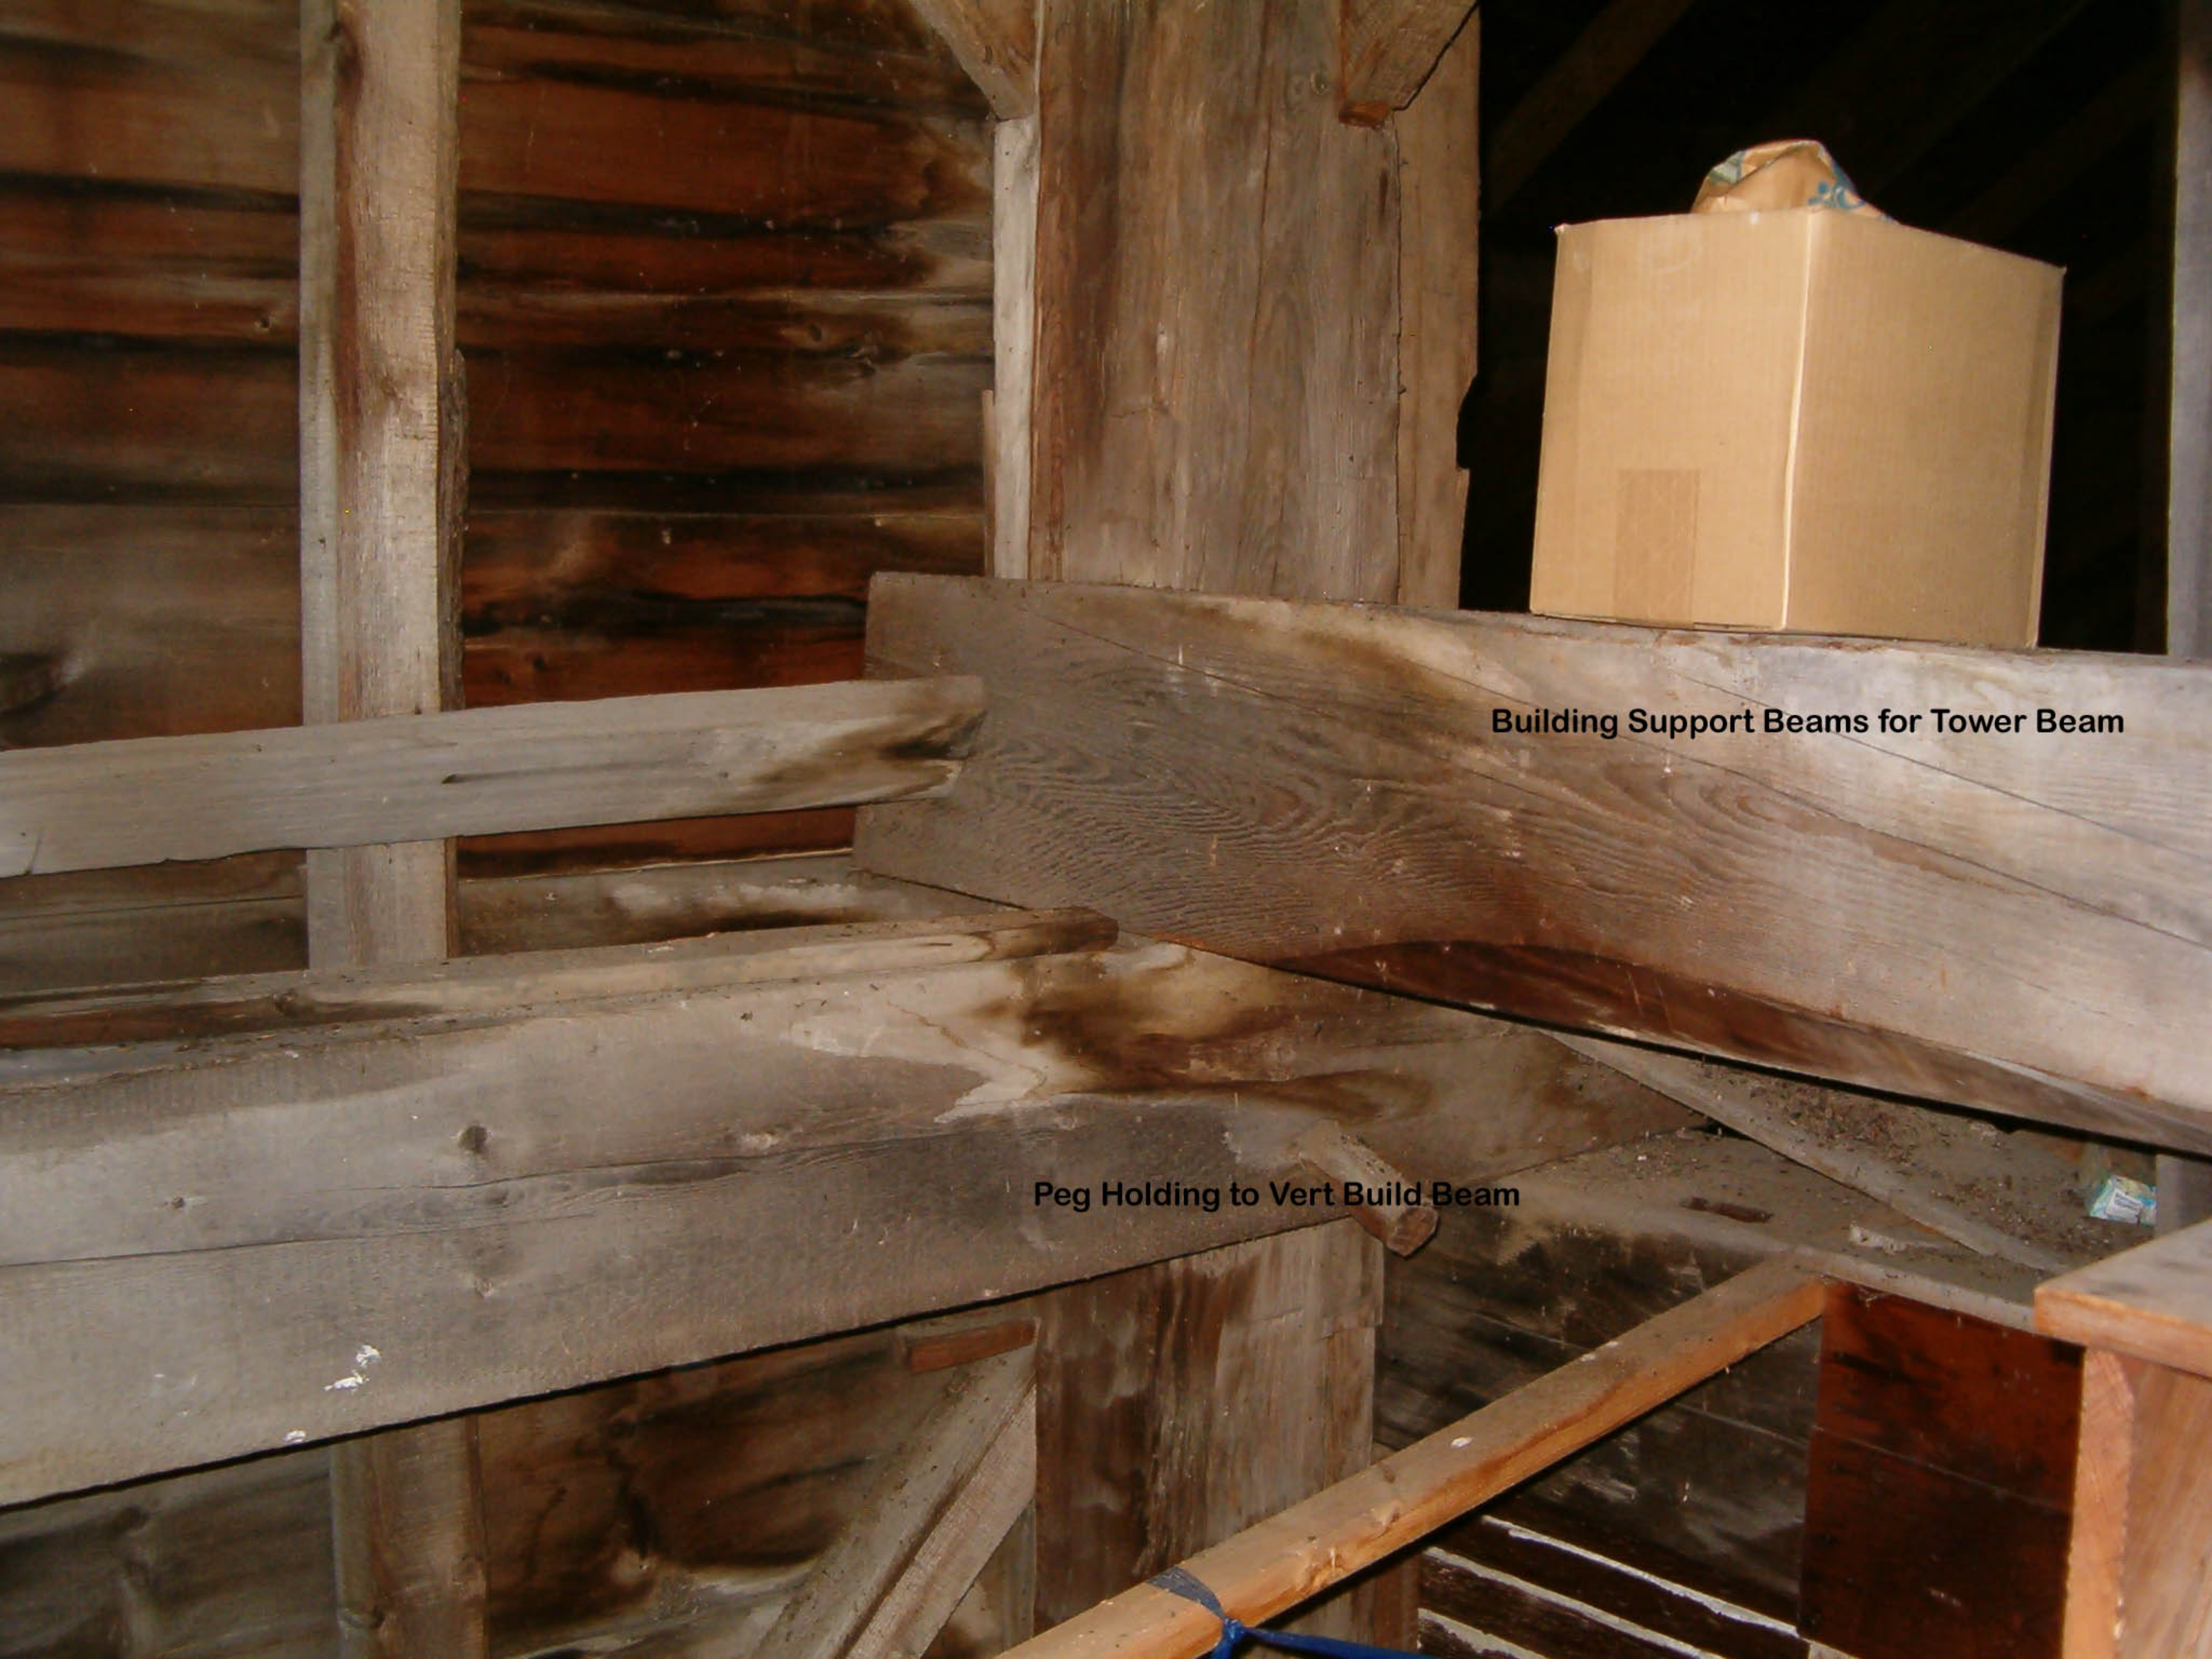
Building Support Beams for Tower Beam

Peg Holding to Vert Build Beam

Rotten Tower Beam

Sawn newer building beam

Peg

Steel Bolt

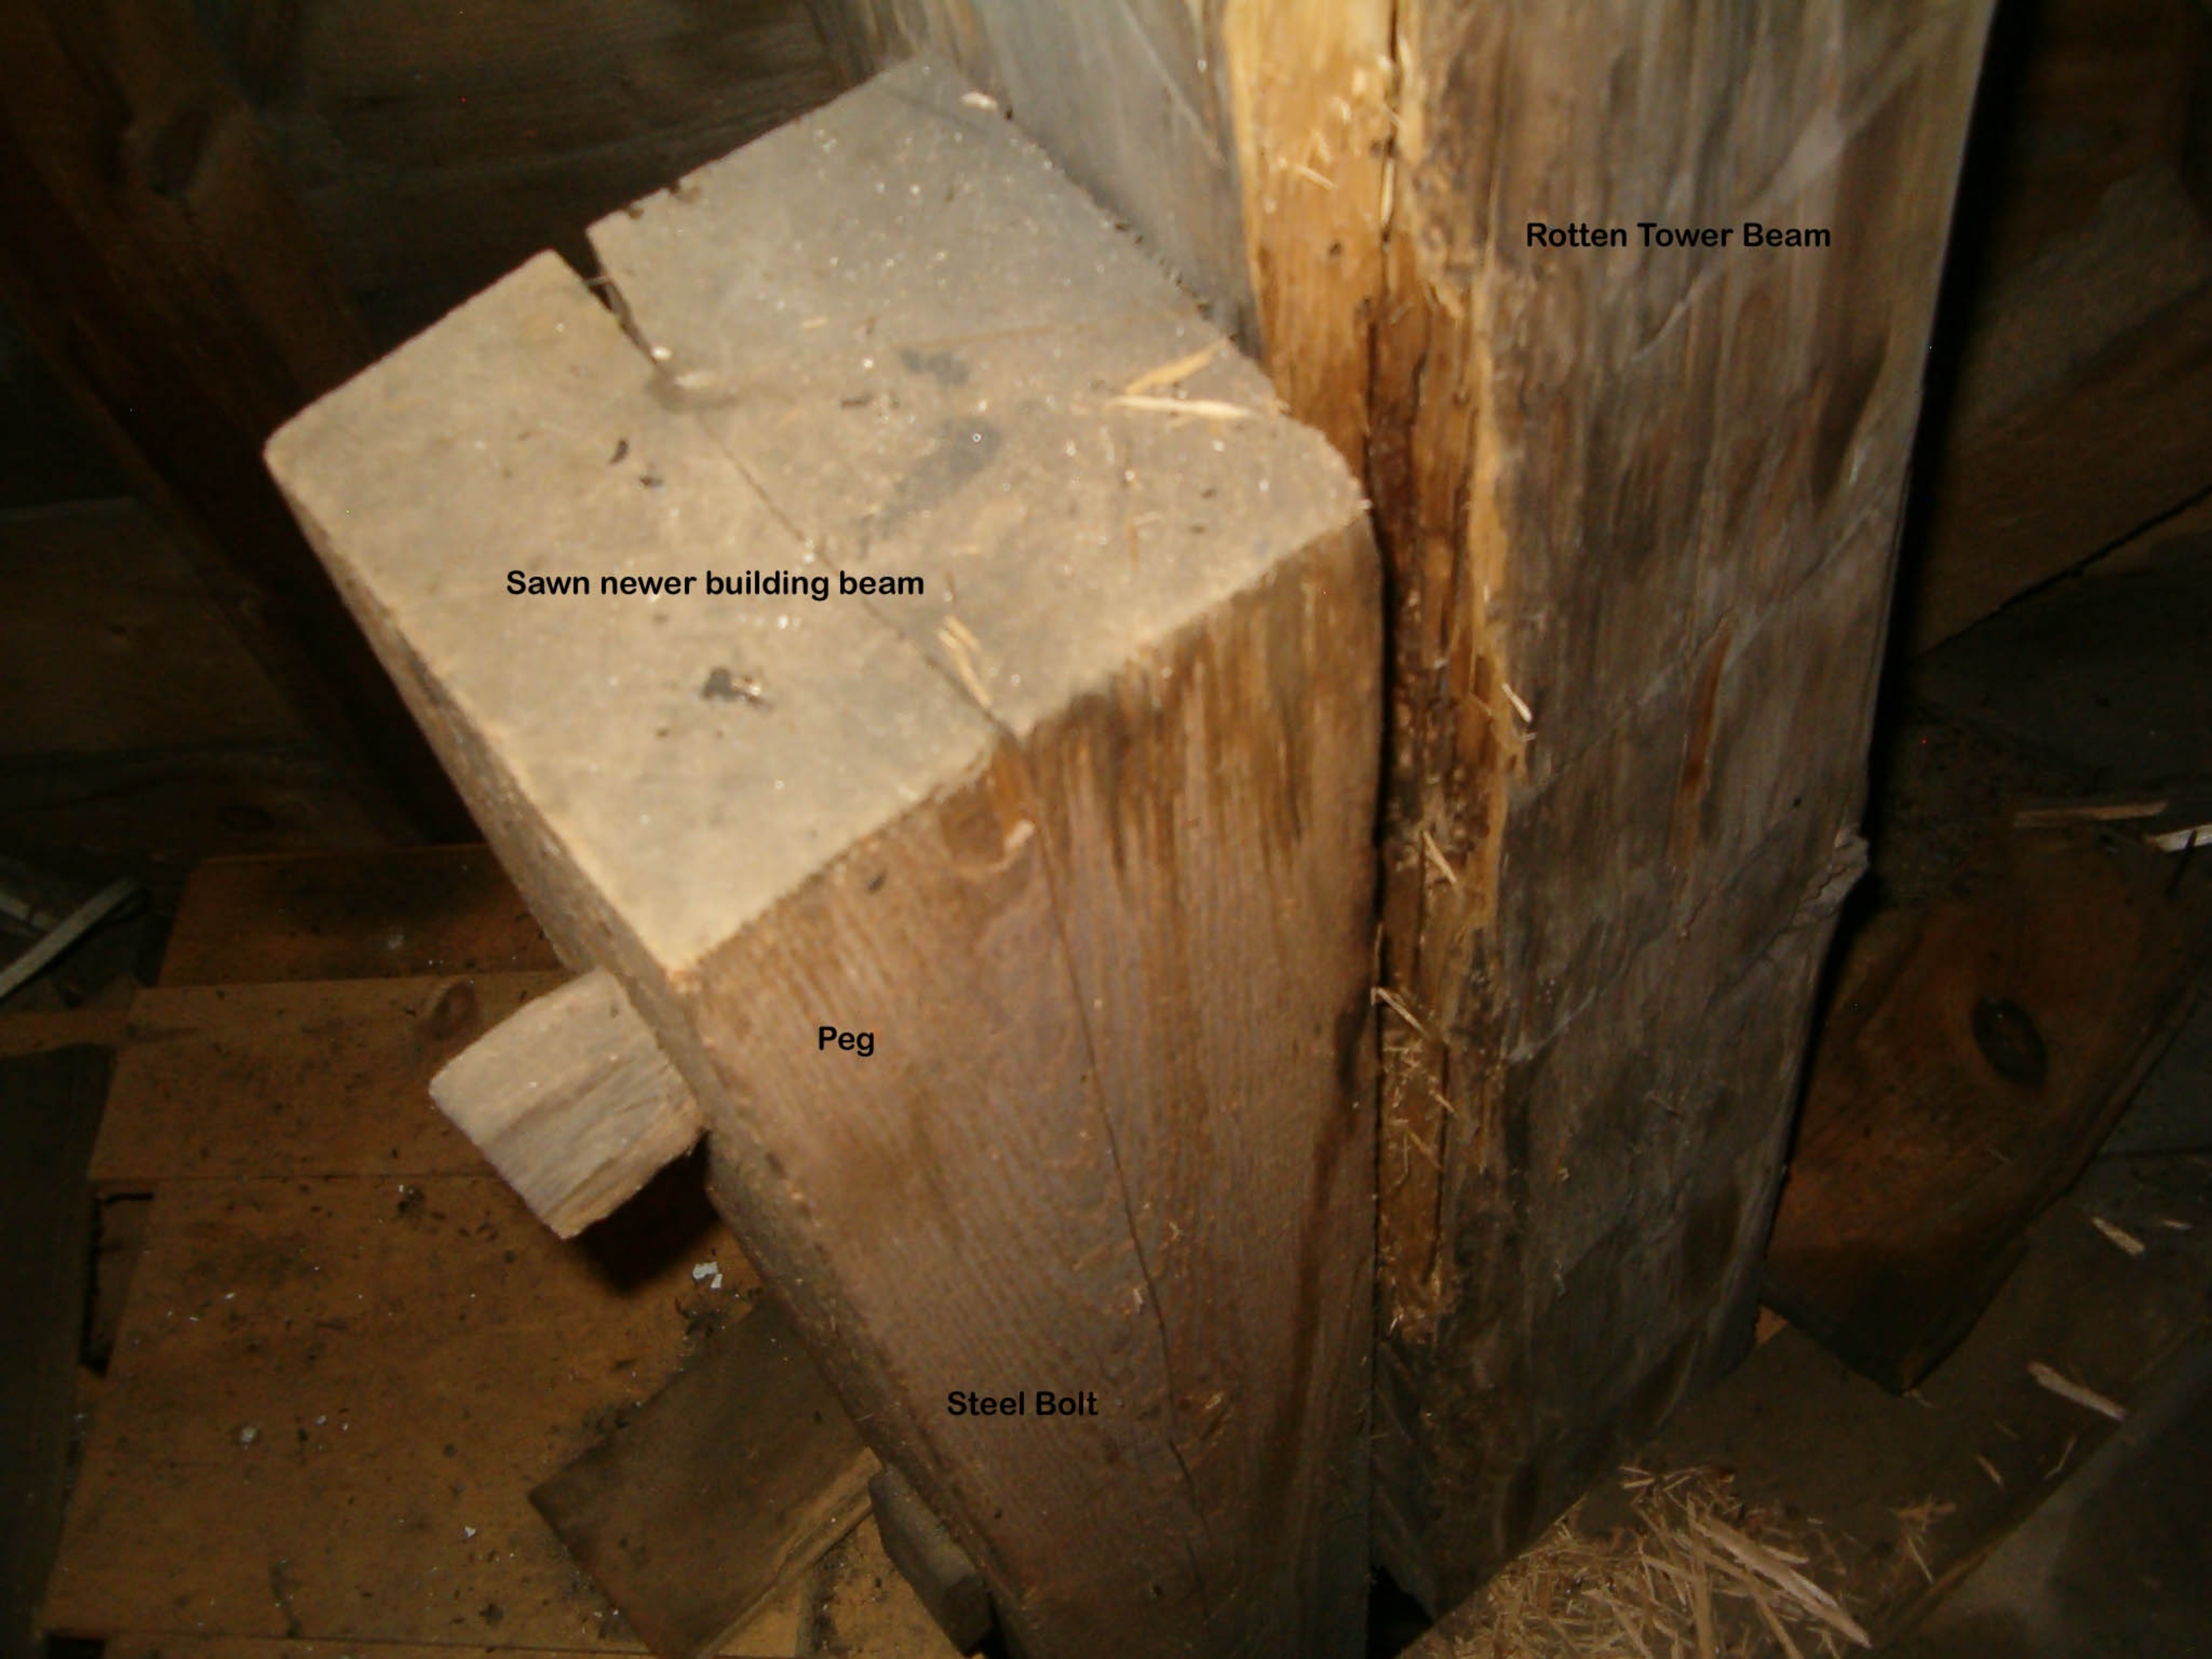
Rotten Beam

Newer sawn beam sistered to rotten

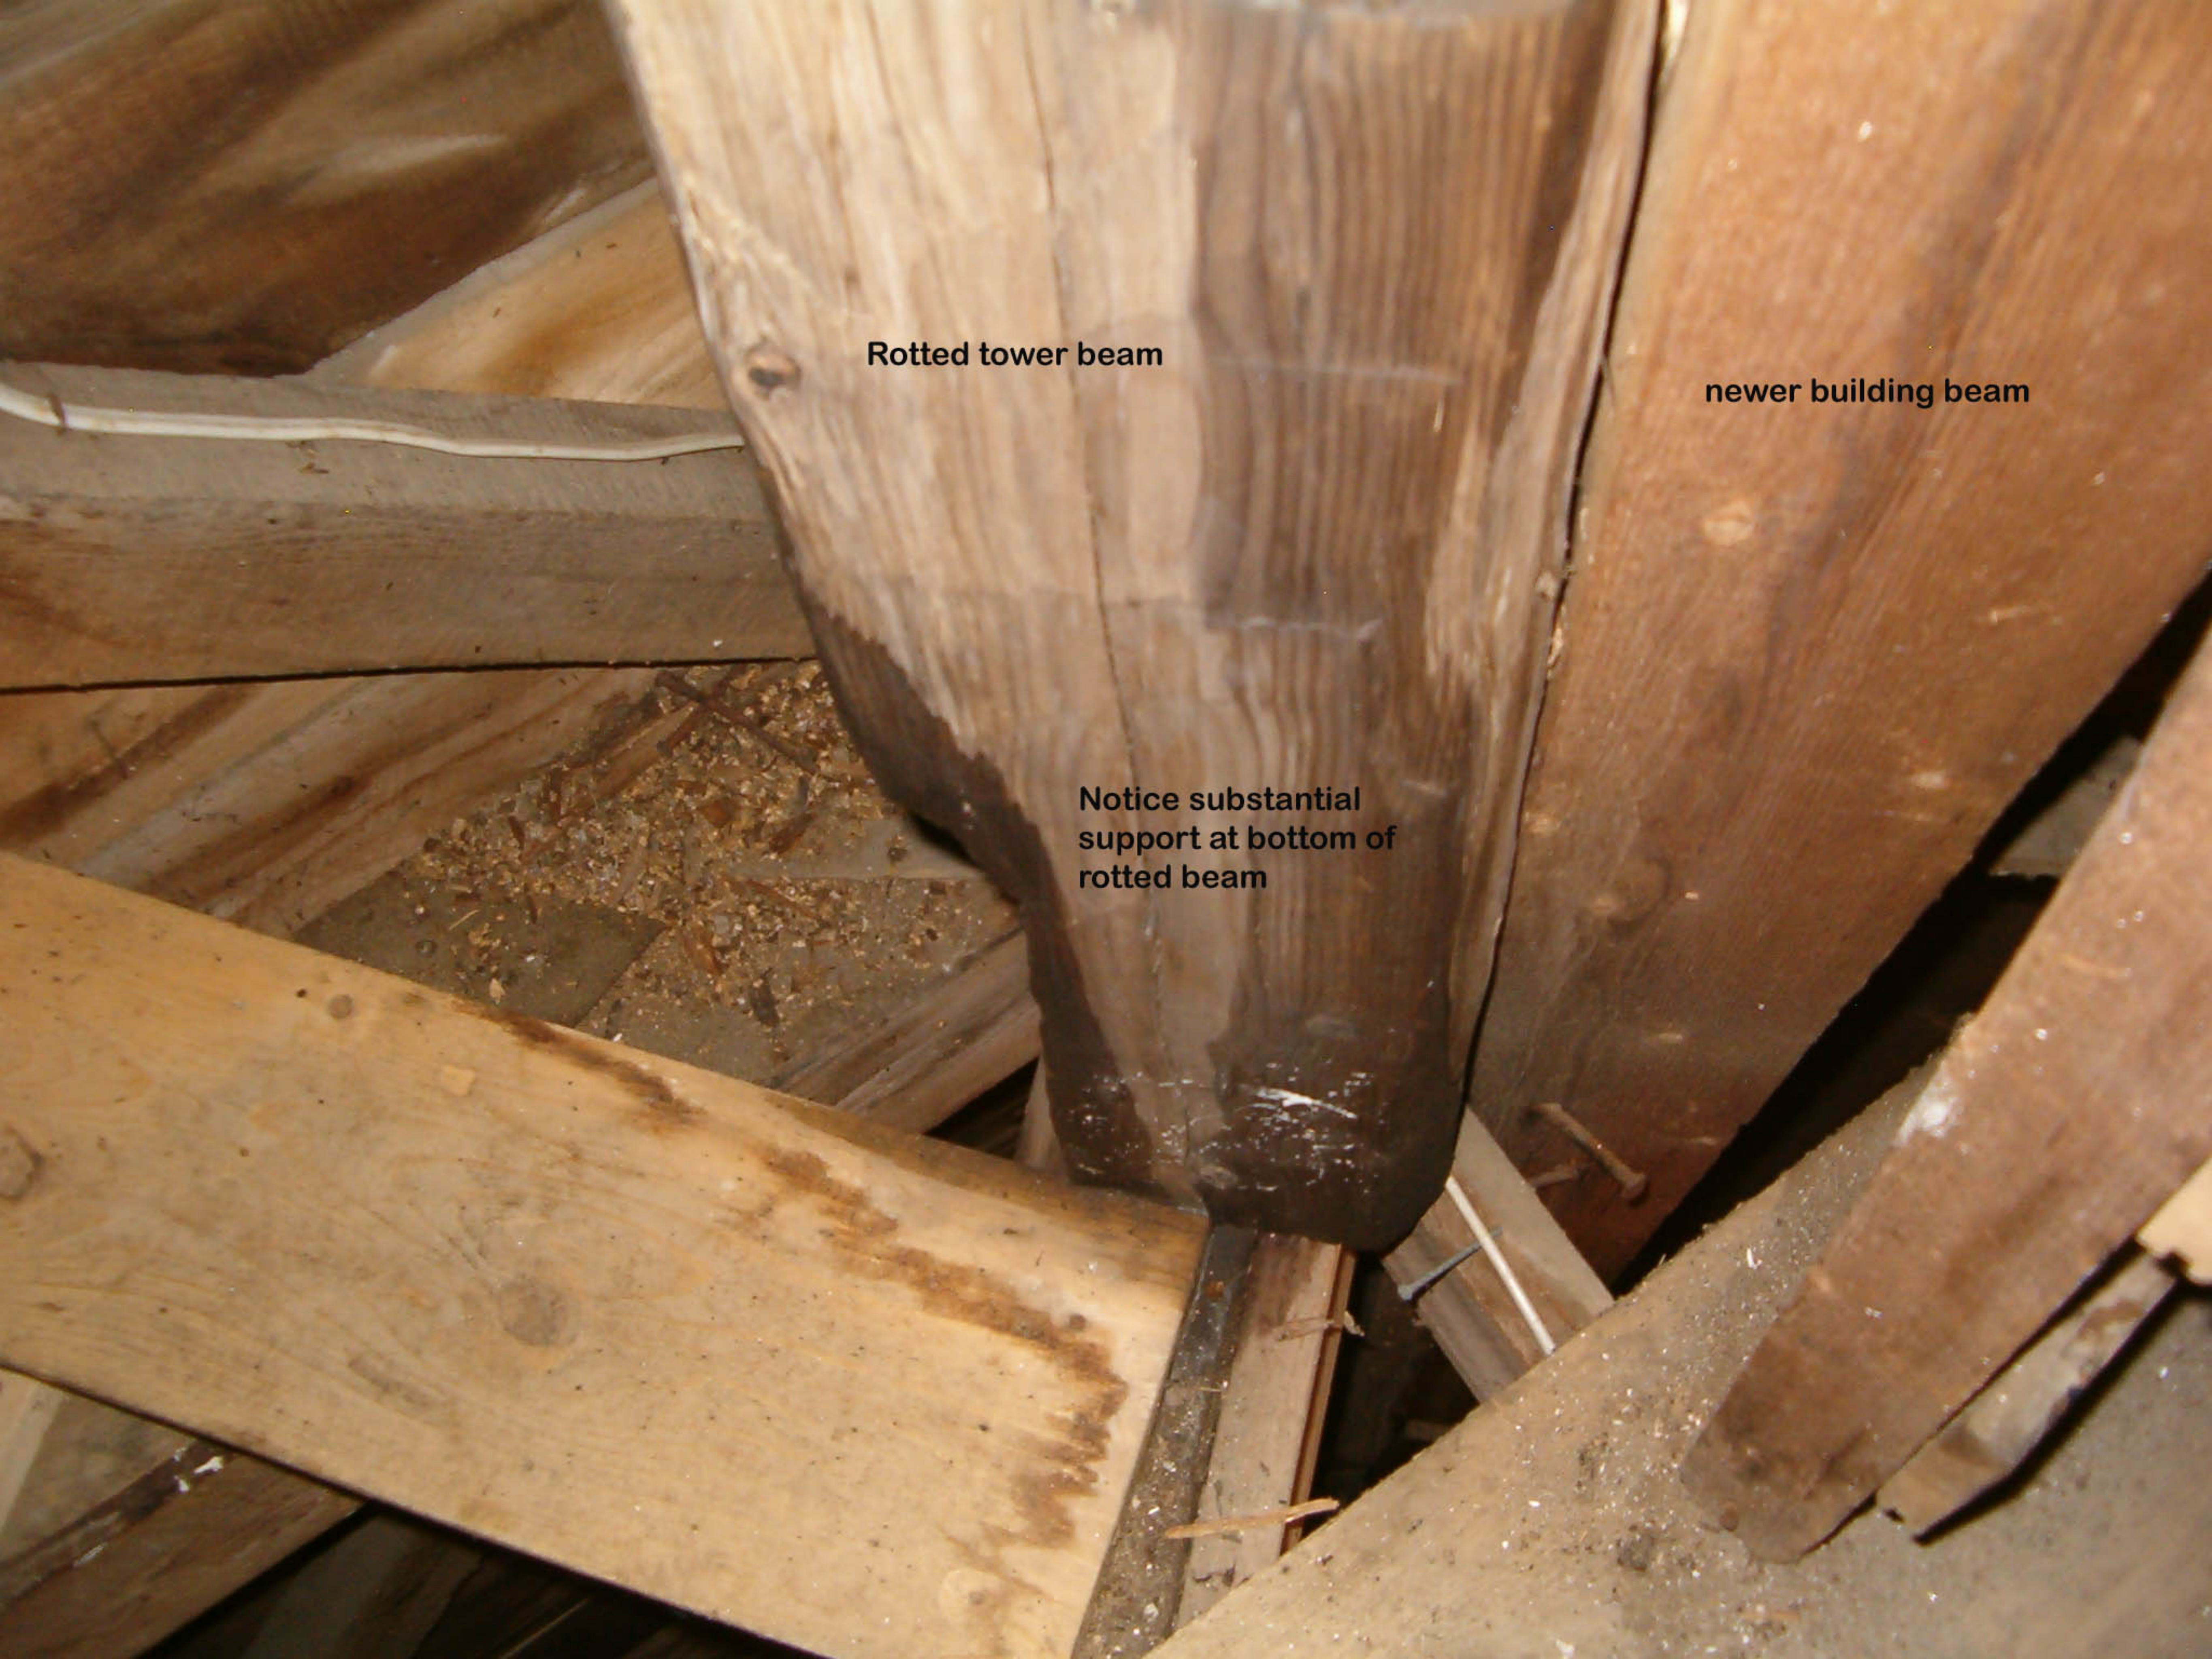
Rotted tower beam

newer building beam

Notice substantial support at bottom of rotted beam

Walls wet

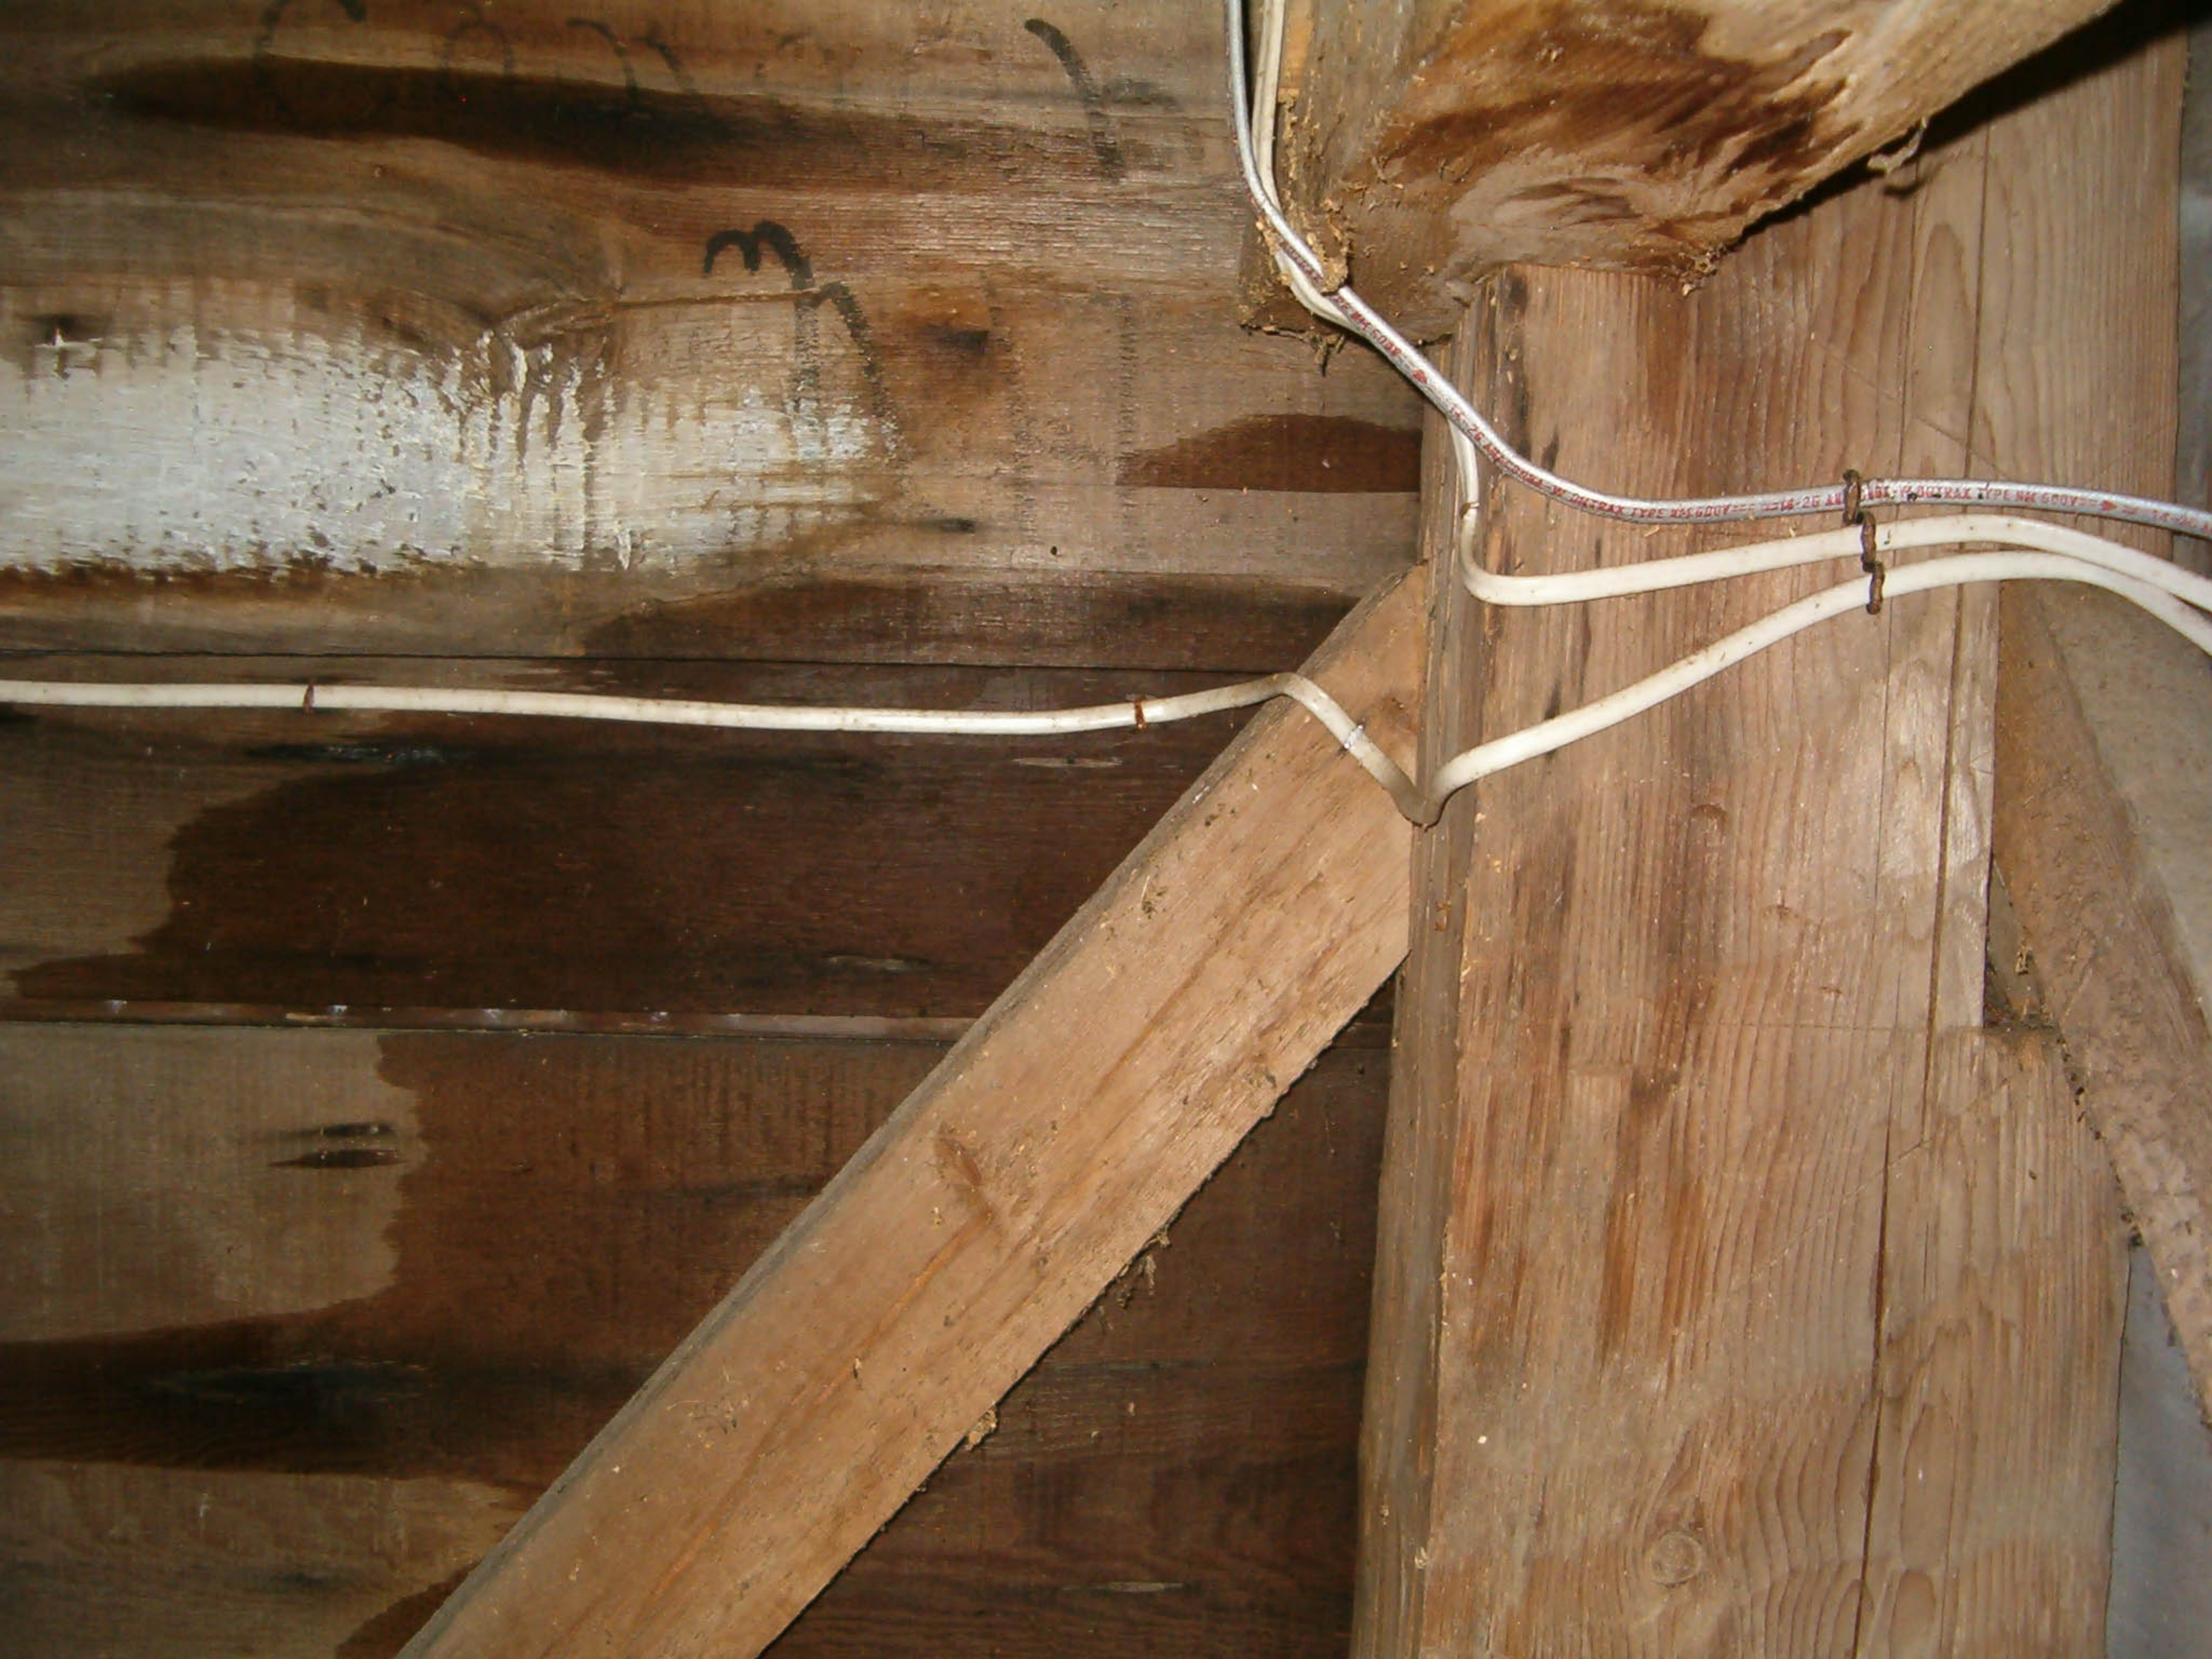
Wet Walls & Floor

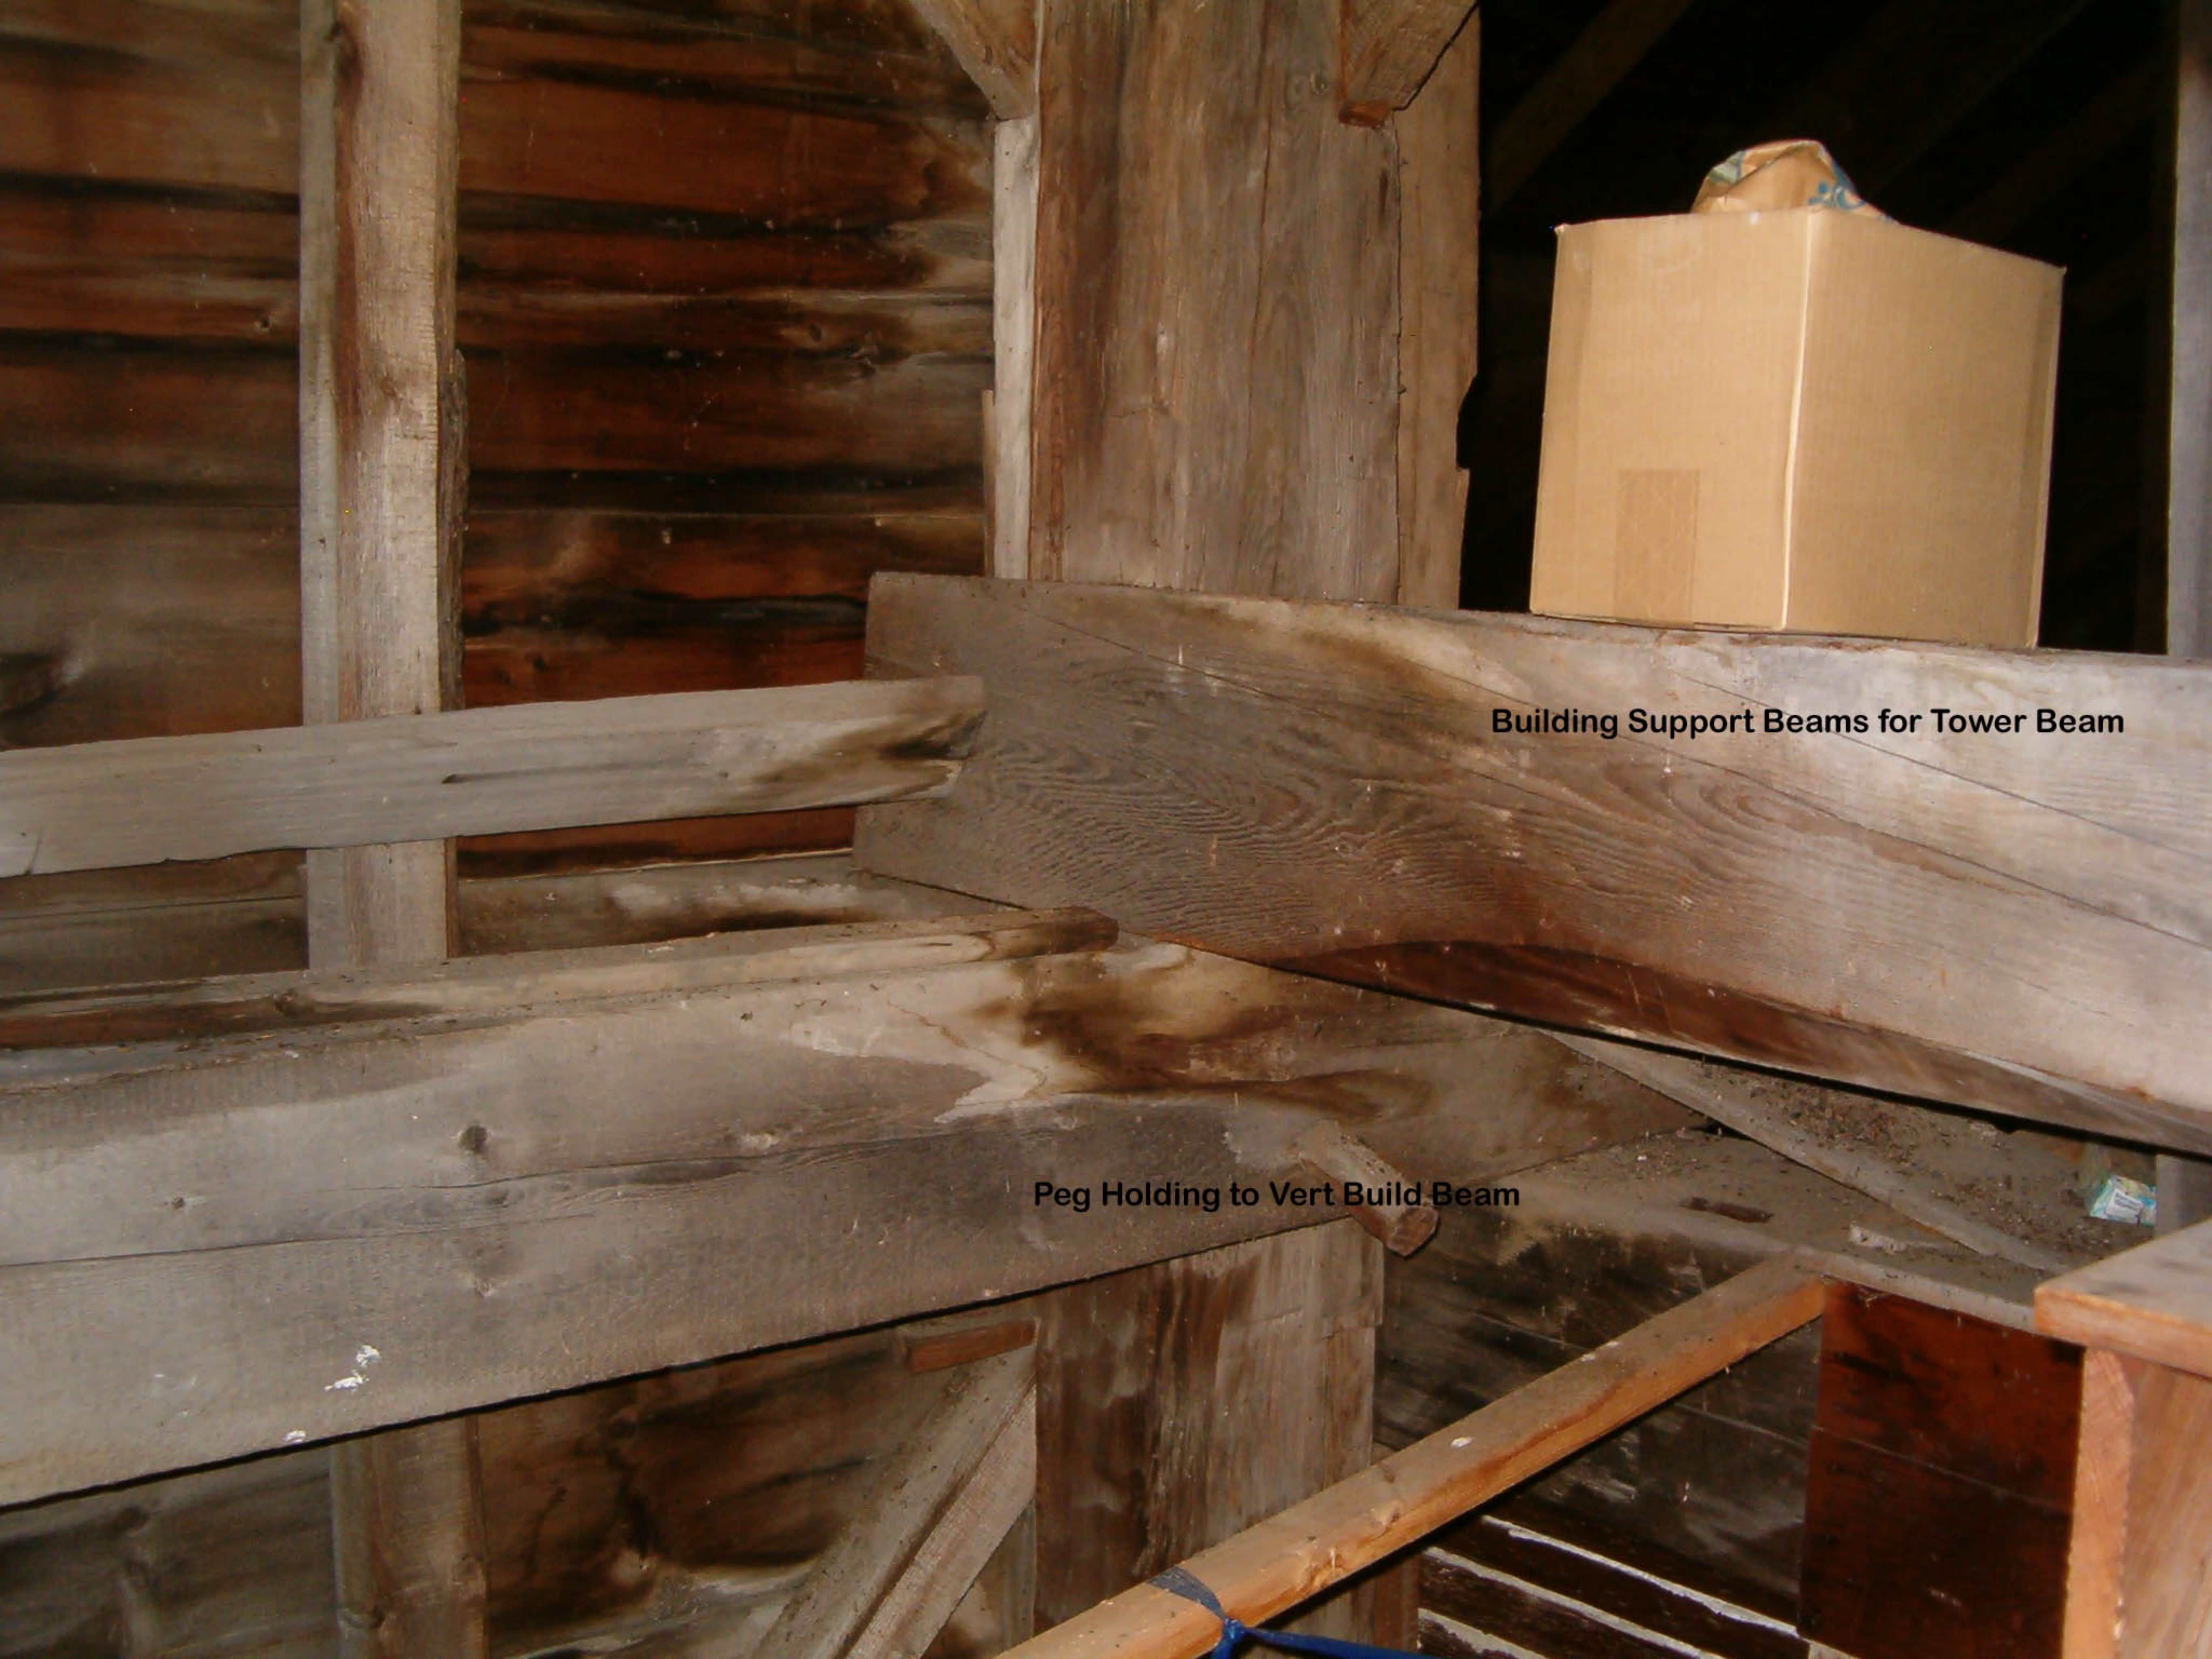
Building Support Beams for Tower Beam

Peg Holding to Vert Build Beam

Rotten Tower Beam

counter weight for clock

Not attached to wall on left

Support Building Beam
For Tower Beam

2 x 4 cross linked to another beam on left

Brace?

3 x 8? holding up
Beam

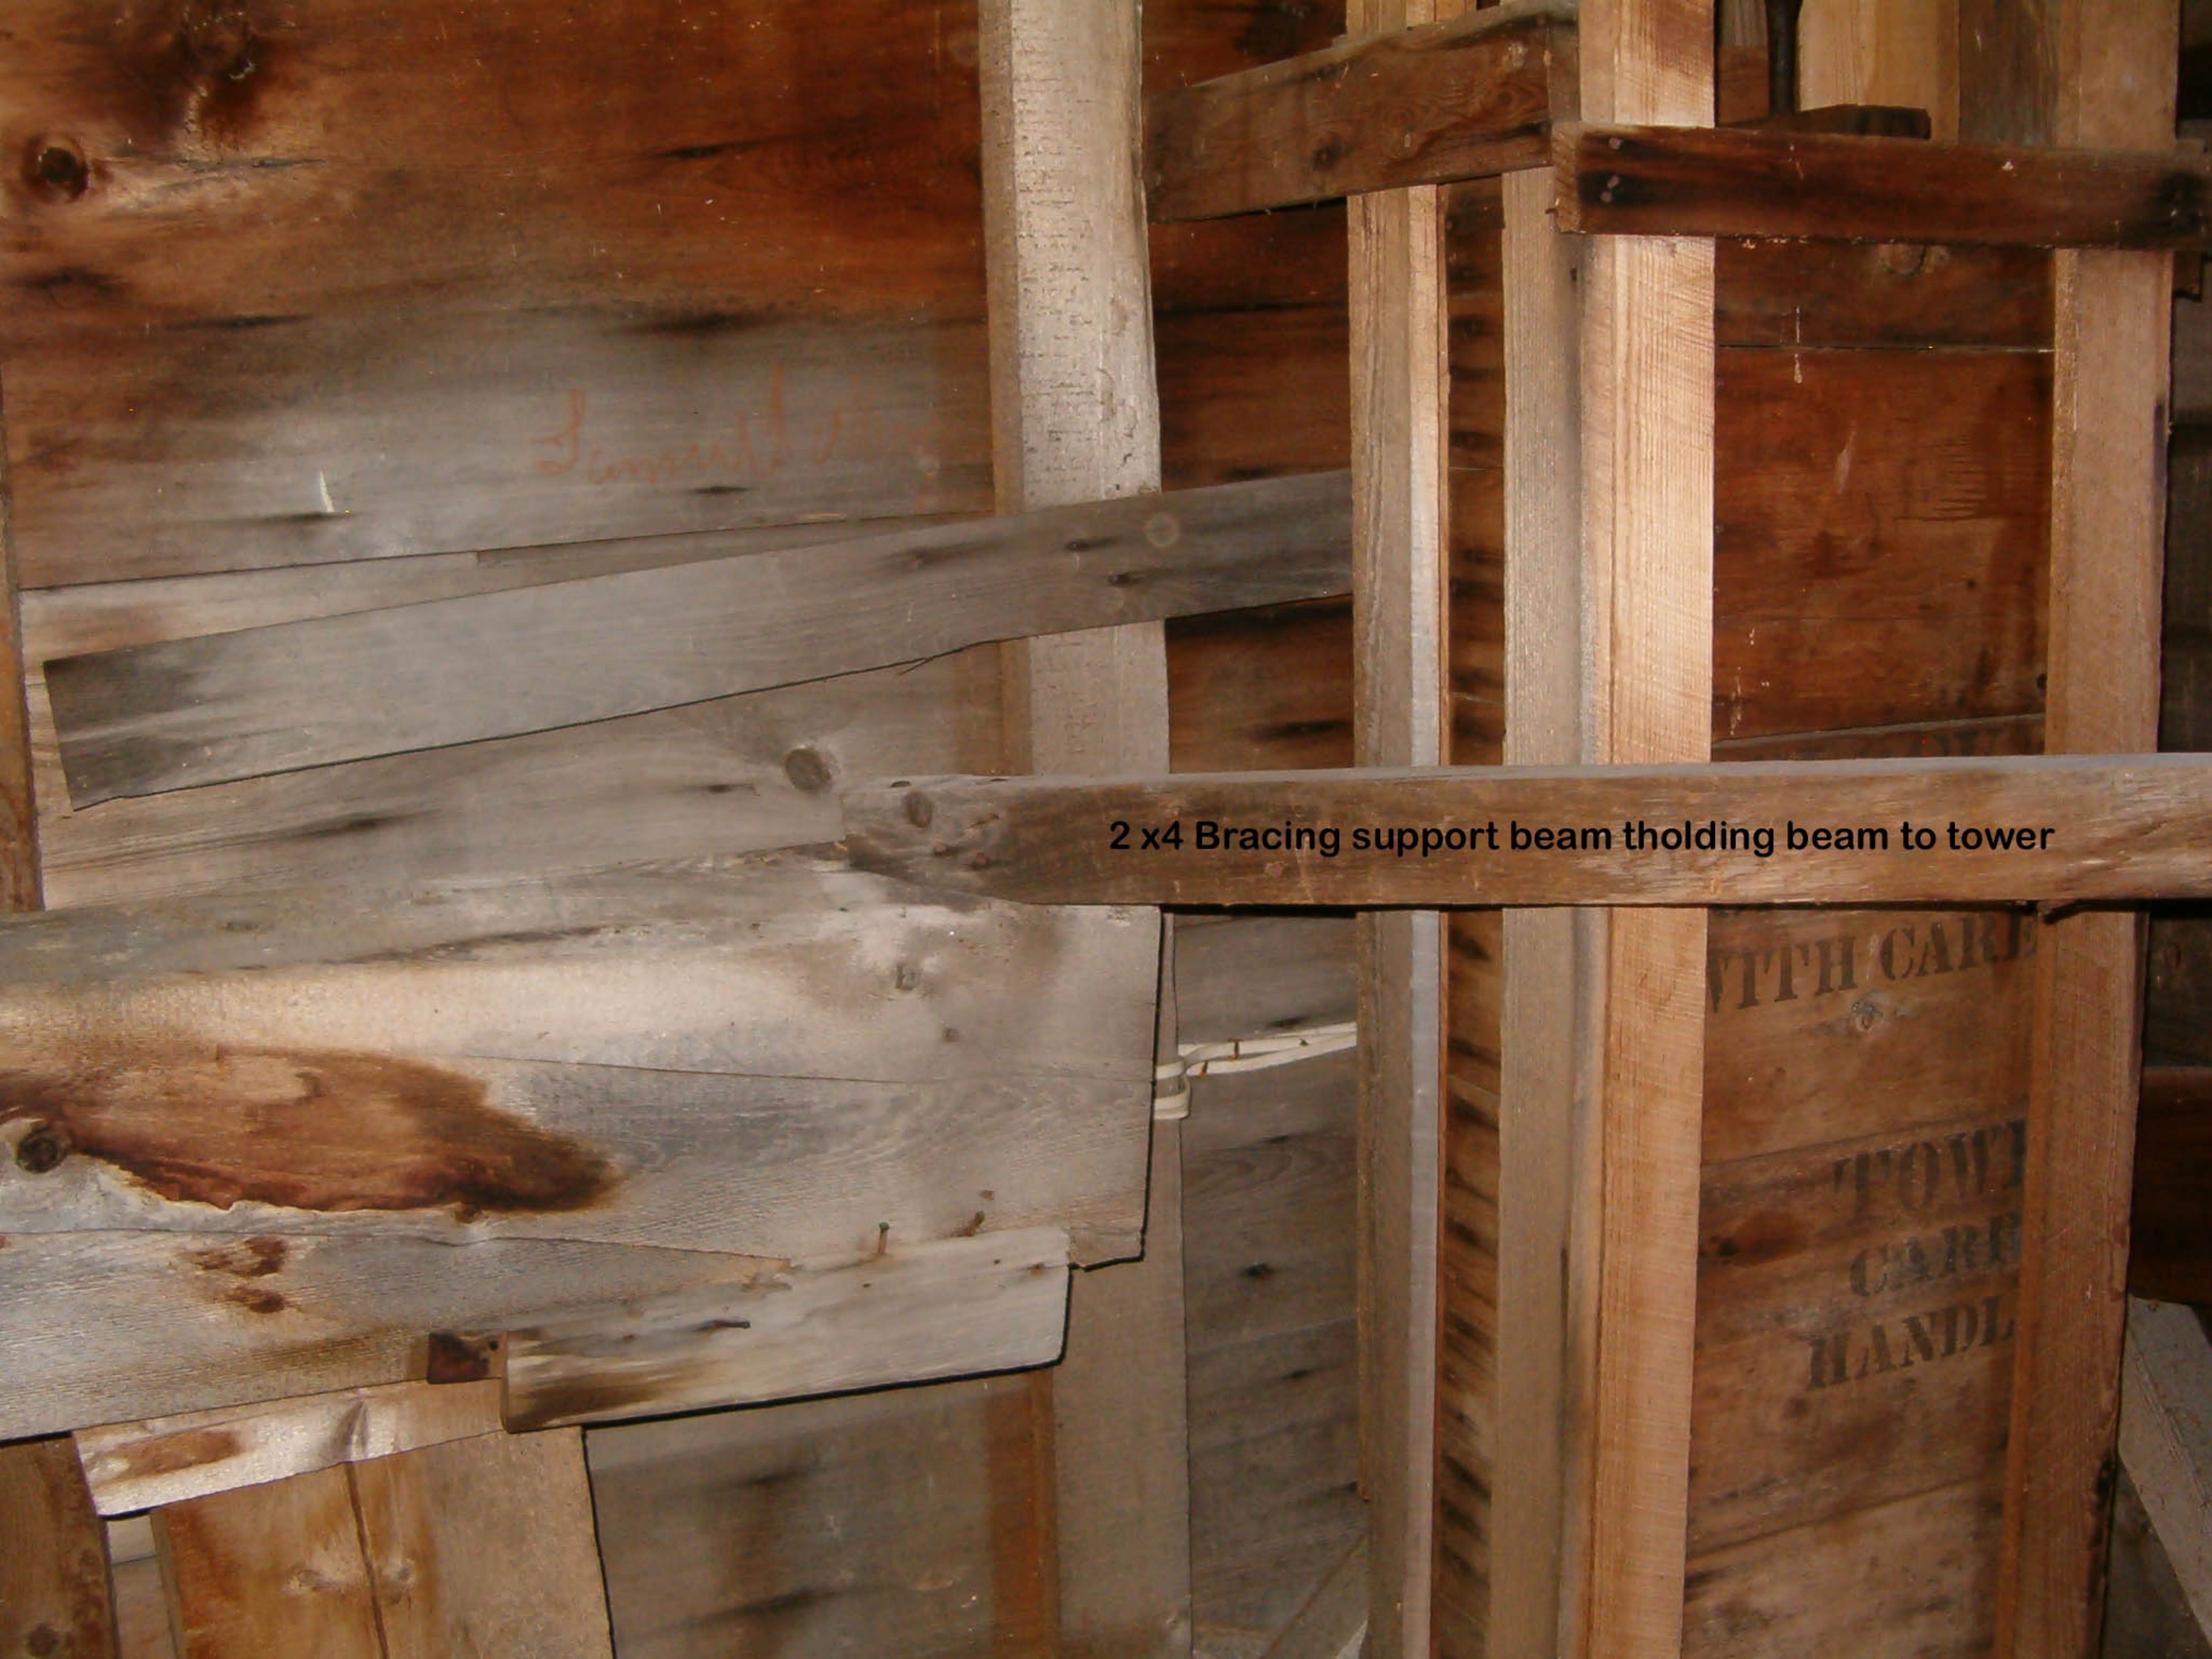
2 x4 Bracing support beam tholding beam to tower

Broken rotten peg between building beam on left rotten tower beam on right
