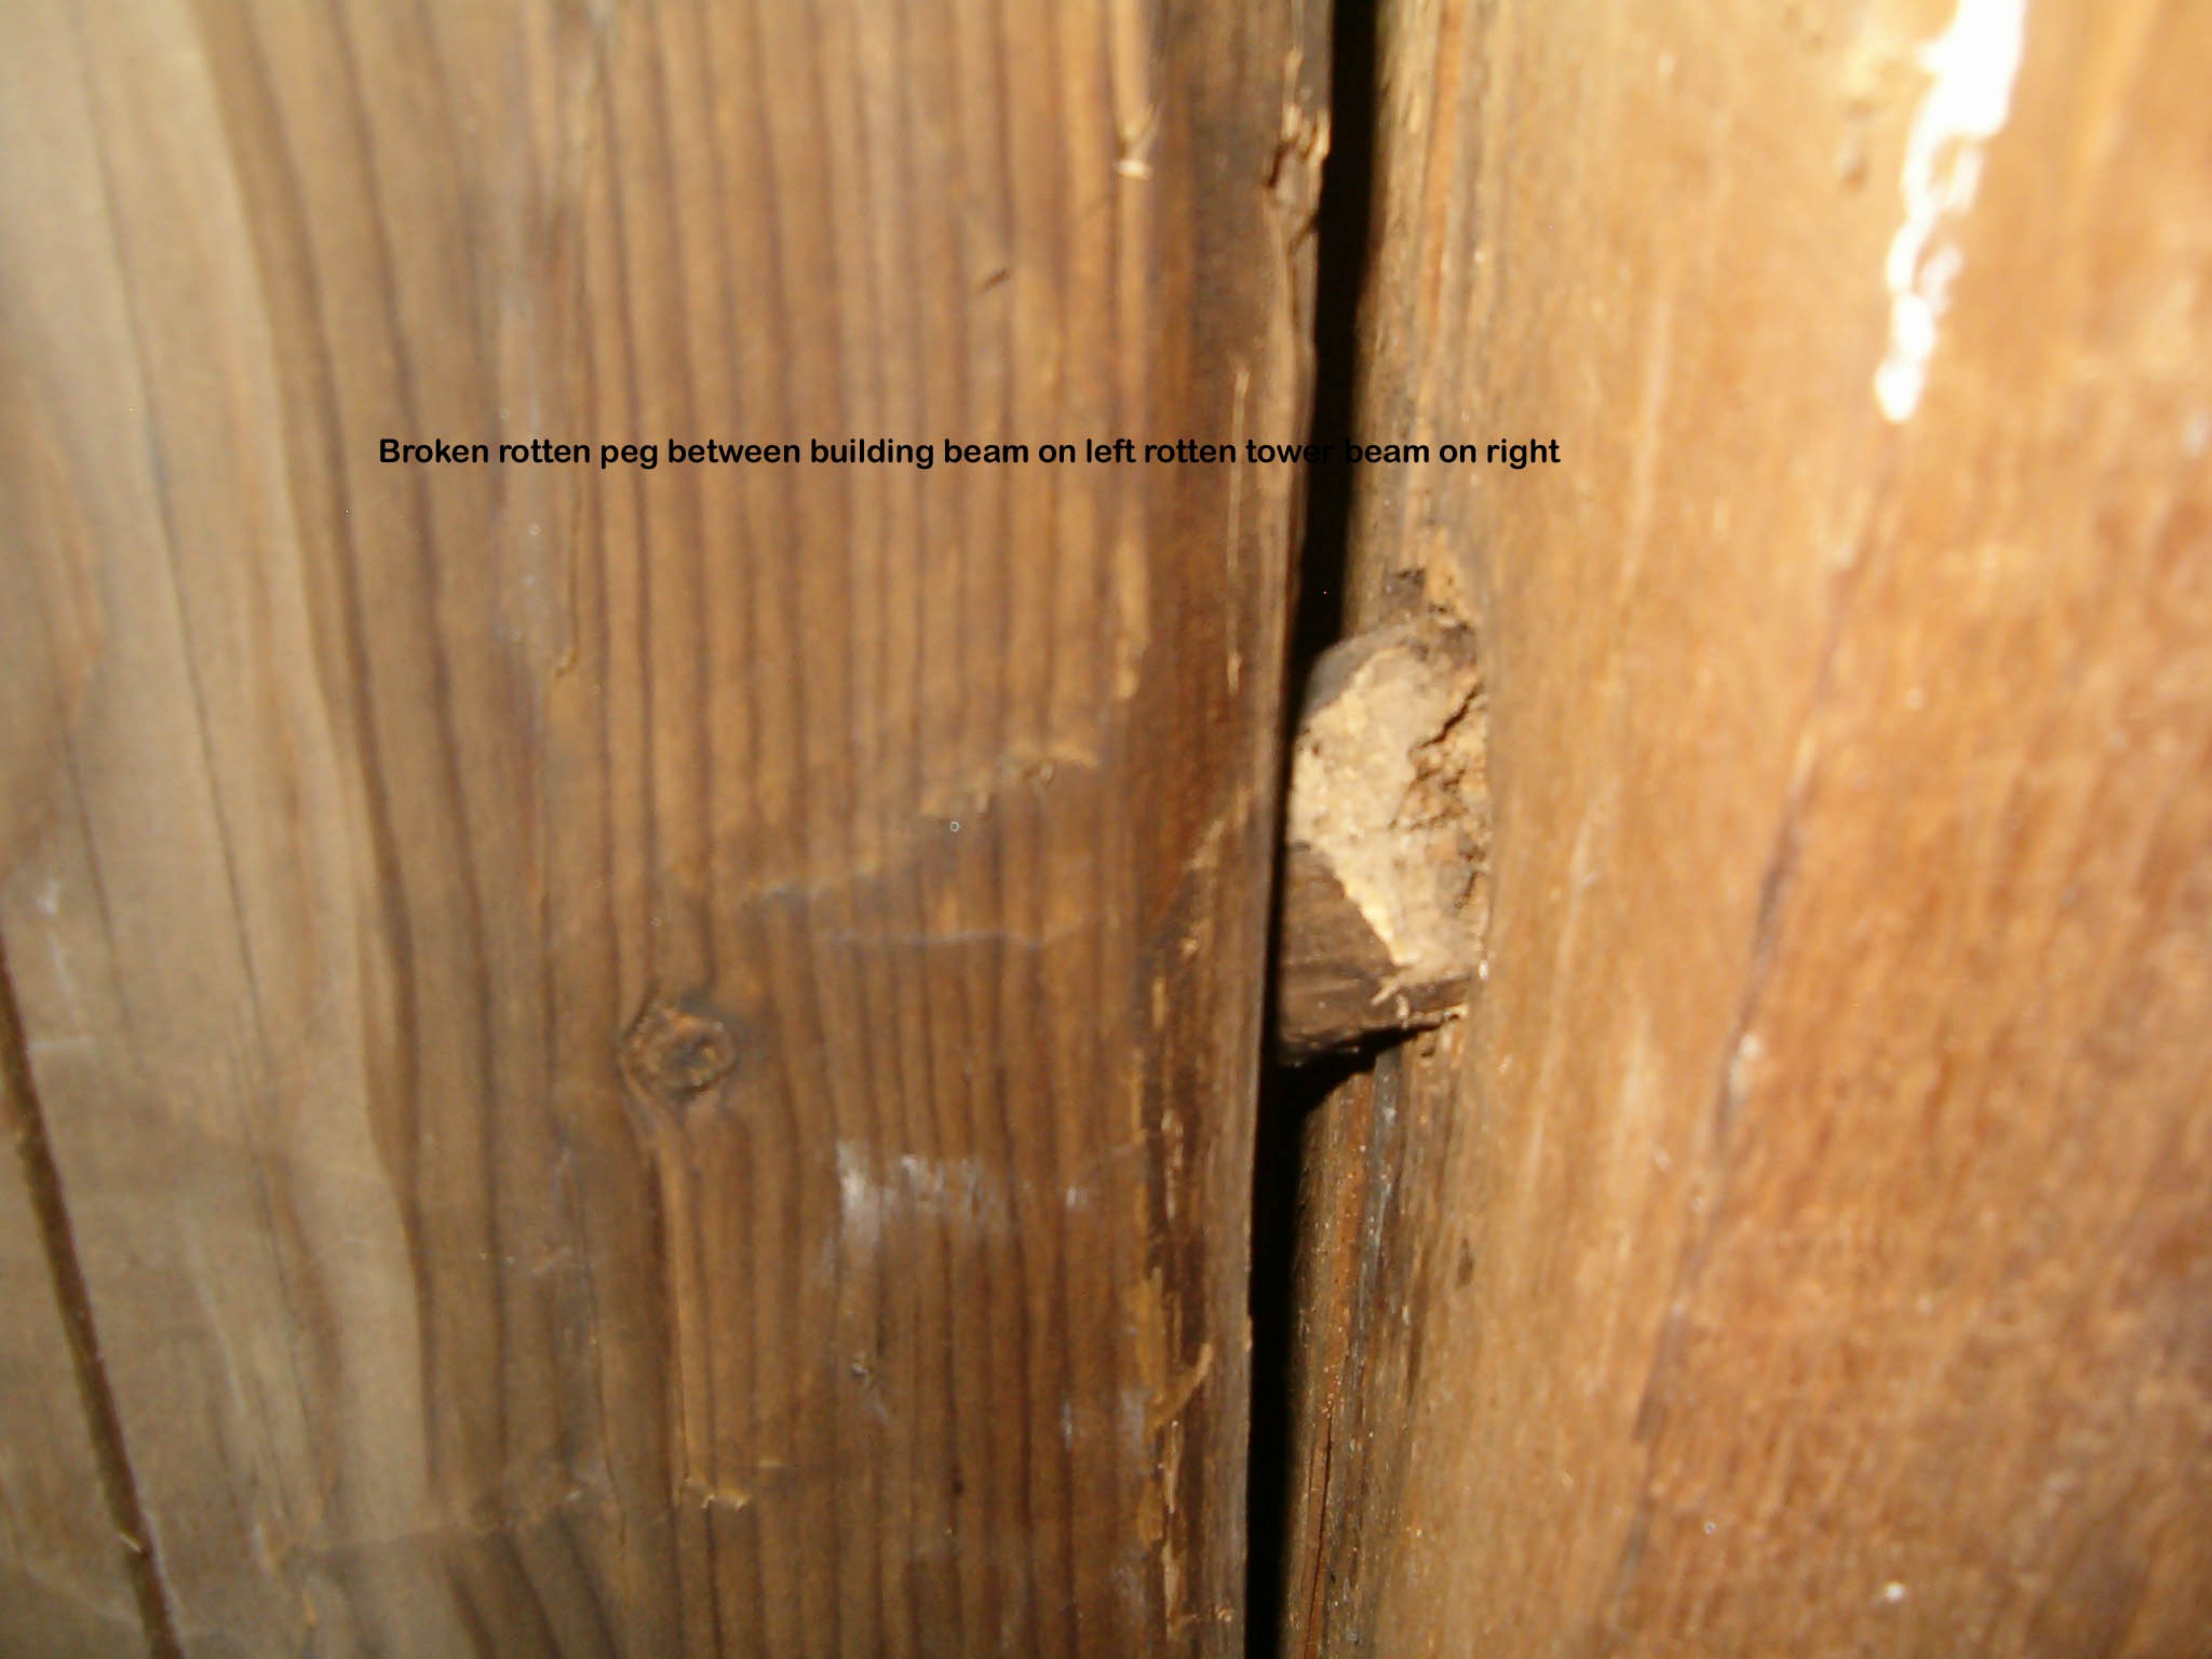
rotten beam tower

wood peg

new post building

Walls wet framing on tower

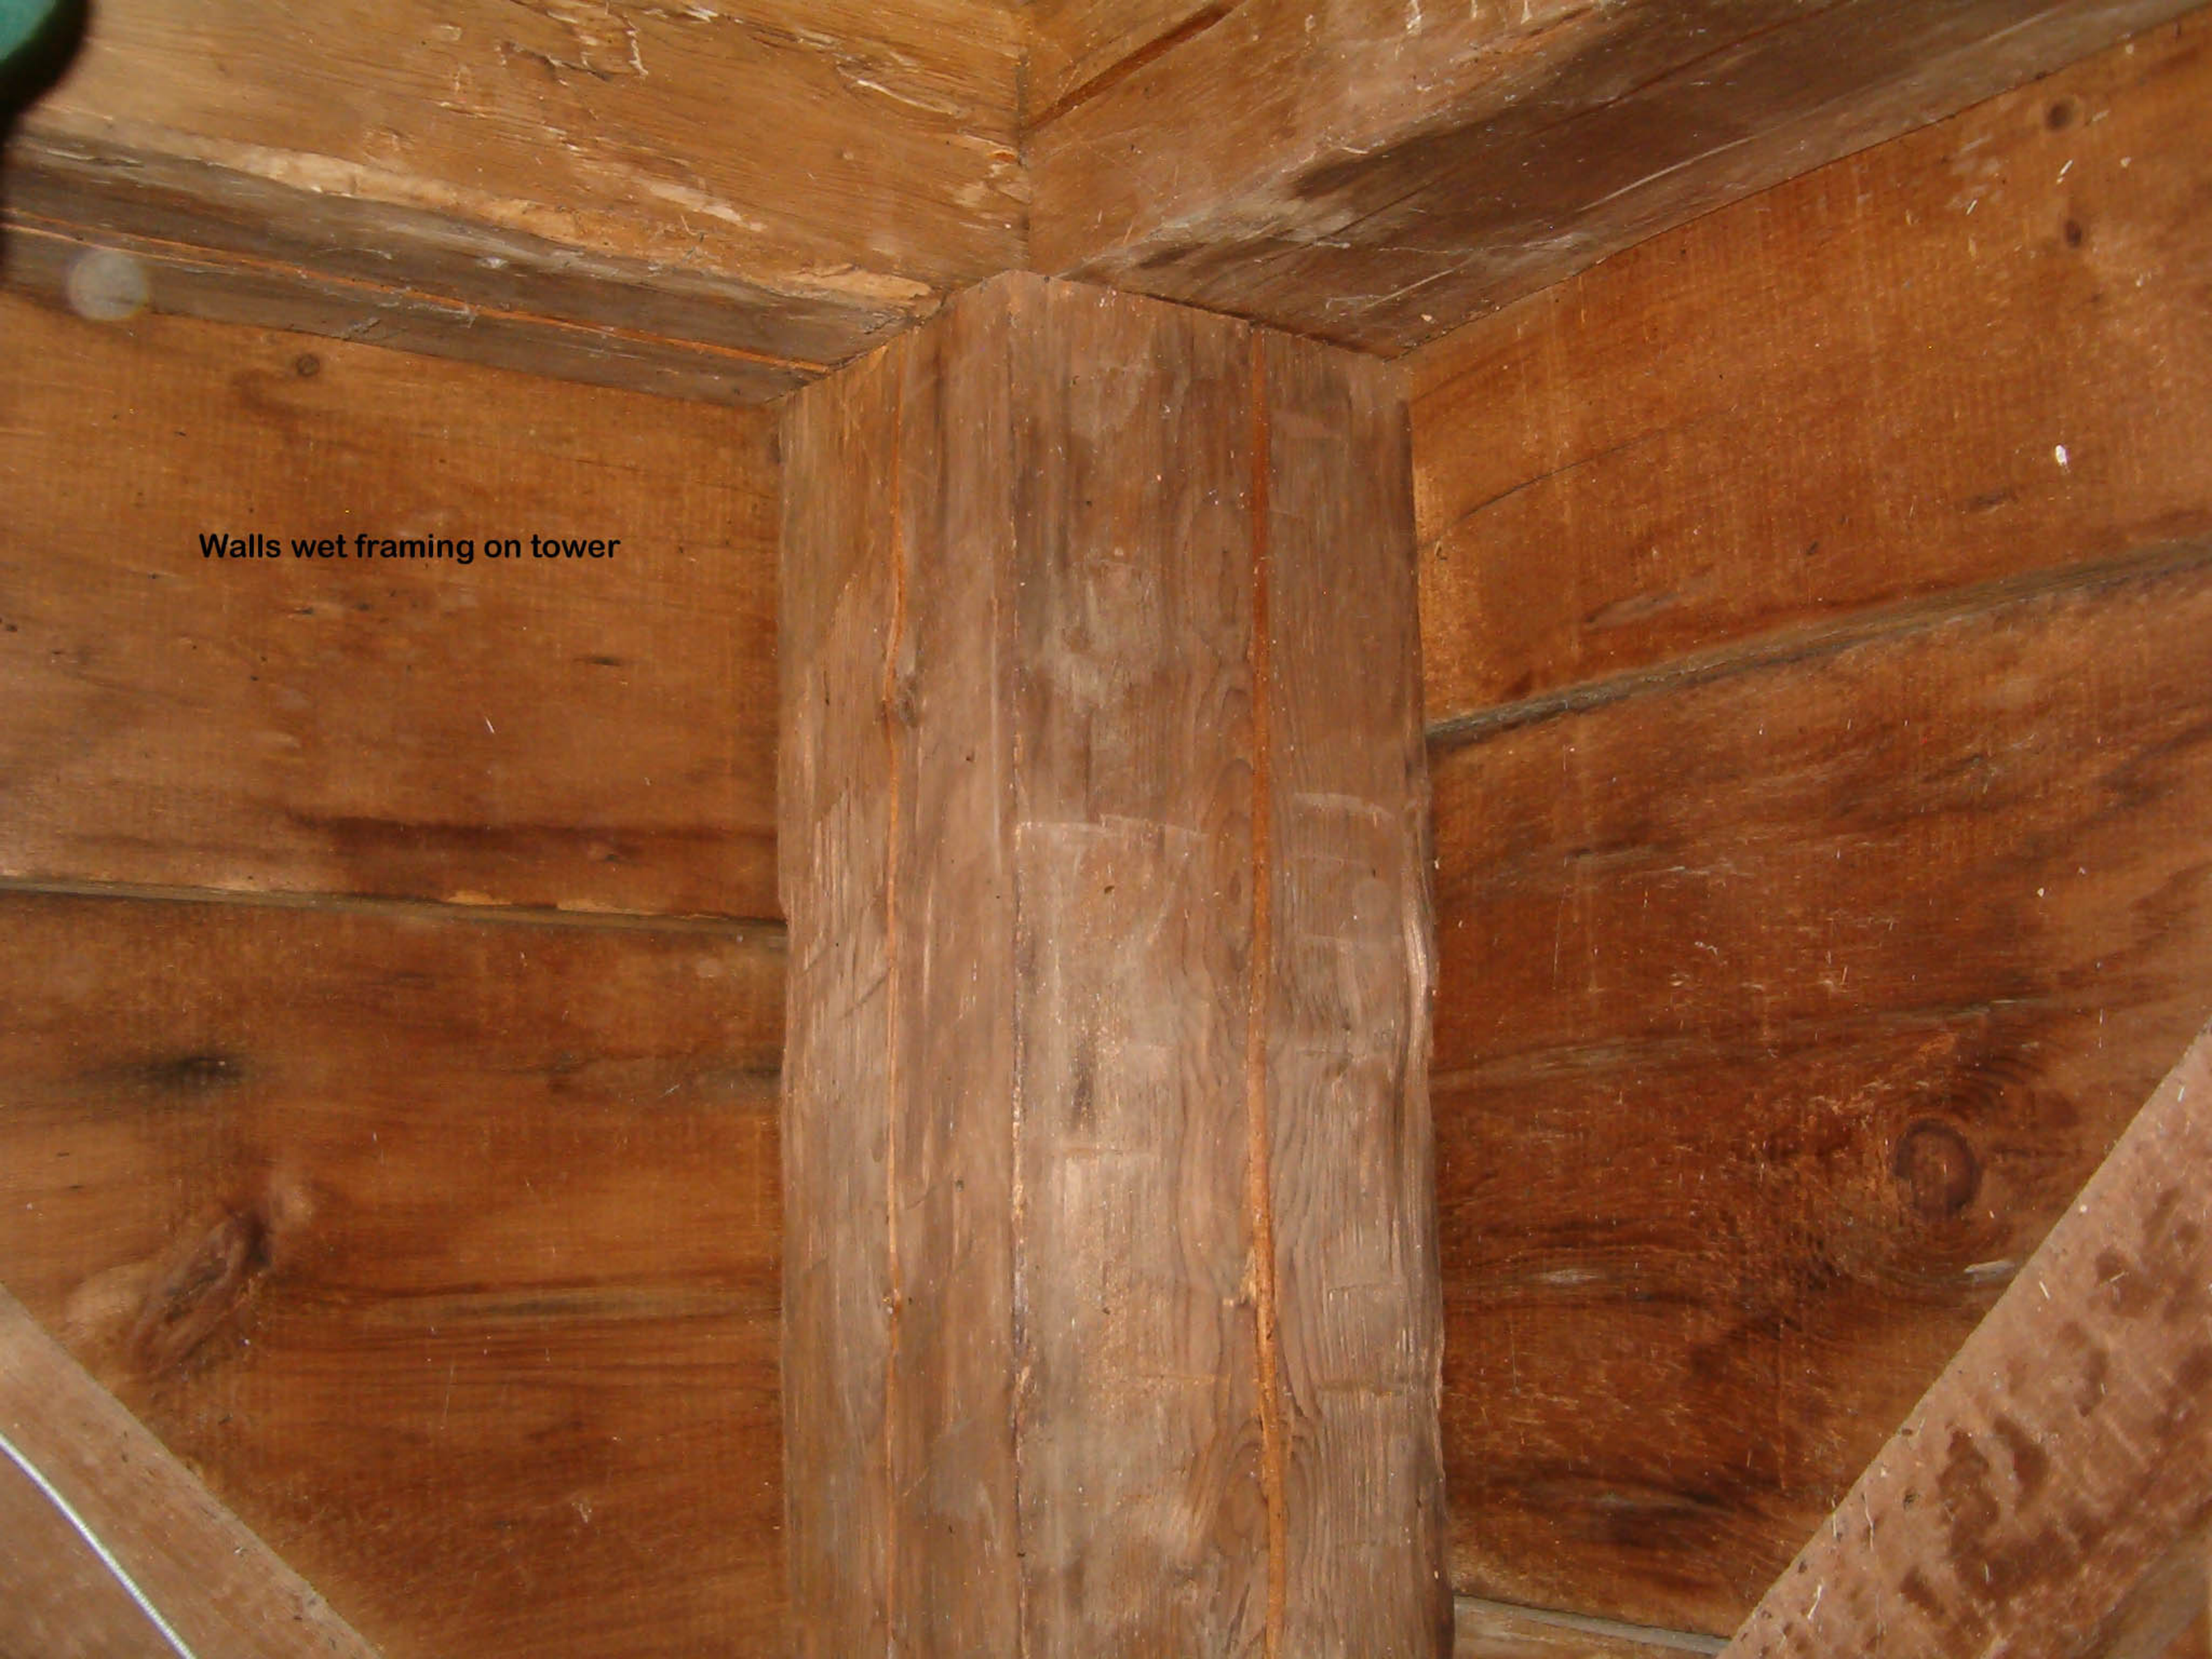
Rotted Tower Beam

Superb Railing
